InSAR Monitoring of Urban Infrastructure: Mitigating Land Deformation Risk

presented by Vivienne WU

- Intro to Land Deformation Monitoring in Urban Context
- Intro to INSAR
- Monitoring Solution Overview
- Case#1: Seattle SR99 Bored Tunnel
- Case#2: Canadian Cases

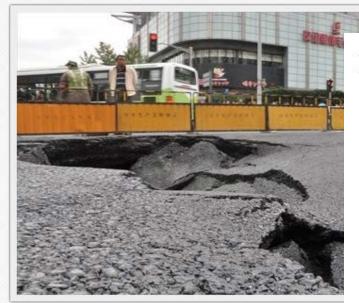
This hole appeared near Shanghai Railway Station to have been caused by subsidence because of mov underground water table. Photo: Cai Xianmin/GT

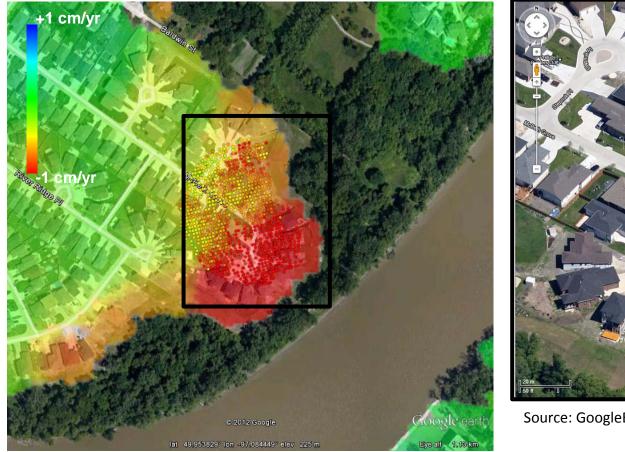
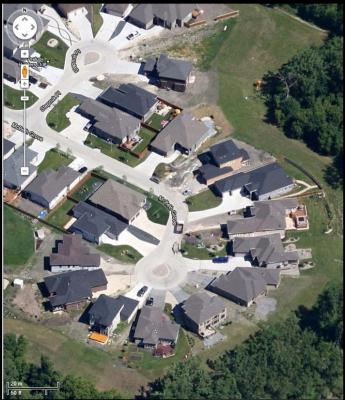
Winnipeg, New Residential Development

Extreme subsidence in a Winnipeg residential area, consistent with slumping of the riverbank.

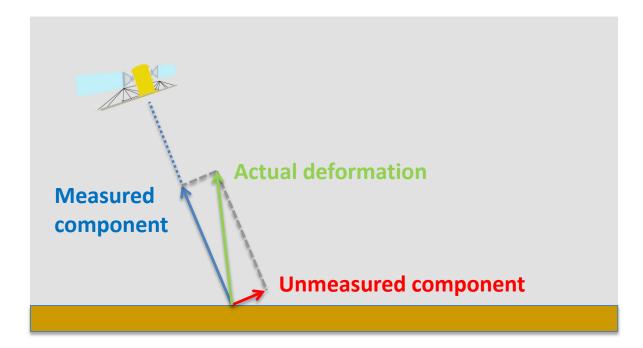
Line-of-sight measurements

- Actual deformation is a 3D vector quantity
- InSAR measures projection of deformation along sensor line-of-sight
 → a 1D quantity
- 2 (or more) view geometries can be combined to measure other dimensions

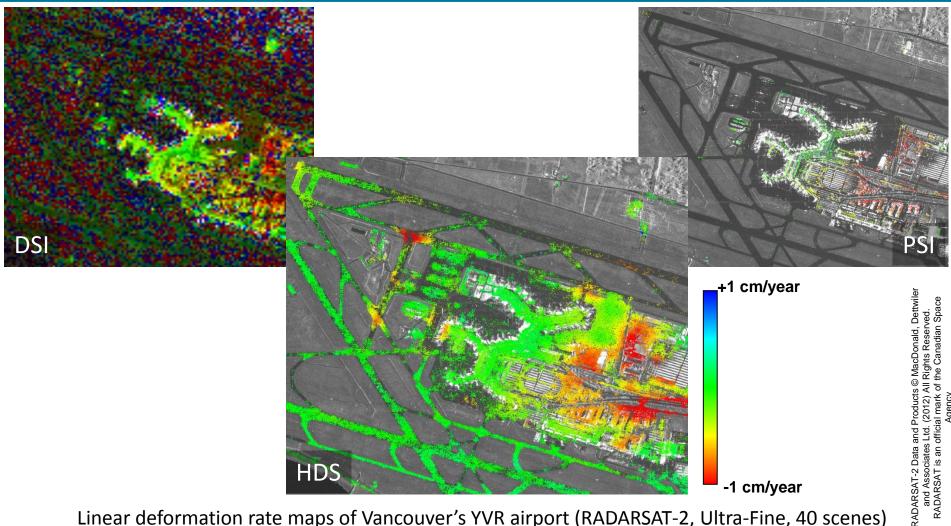
InSAR Methods

Linear deformation rate maps of Vancouver's YVR airport (RADARSAT-2, Ultra-Fine, 40 scenes)

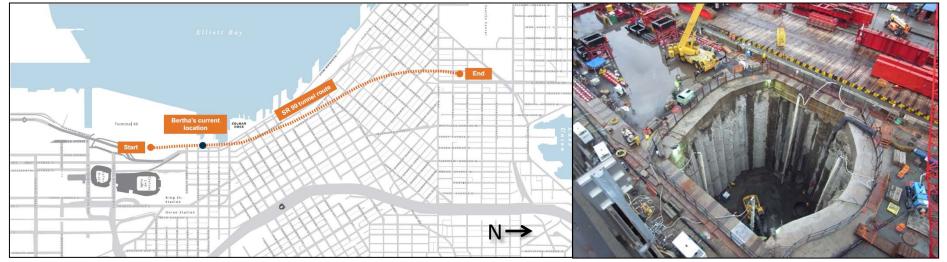
SR99 Tunnel Project

- 3.2 km bored tunnel under downtown Seattle, U.S.A.
- 17.5 m diameter tunnel boring machine \rightarrow 'Big Bertha'
- TBM failed after 10% completion of tunnel
- Repair involves 24 m wide x 37 m deep rescue shaft with significant dewatering required → potential for surface displacement

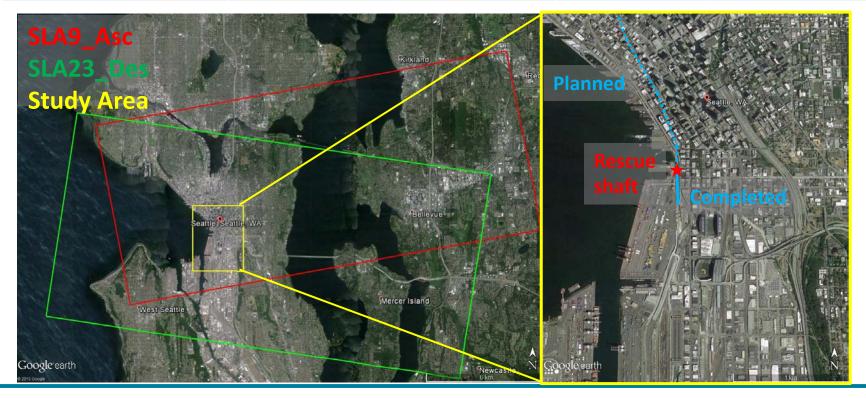
RADARSAT-2 data

Stack	Start Day	End Day	Number of Scenes	Incidence angle (degrees)
SLA9 Ascending	2012/06/06	2015/02/15	41	37.0
SLA23 Descending	2012/06/06	2015/02/15	38	46.7

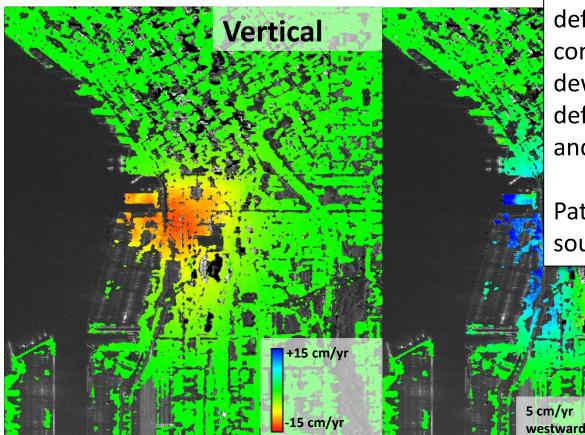
2012/06/06 - 2014/11/01 : no deformation 2014/11/01 - 2015/02/15 : linear deform Dev

Dewatering correlated deformation is spatially consistent with localized dewatering induced deformation (both in vertical and east/west directions).

Pattern centered ~200 m south-east of rescue shaft.

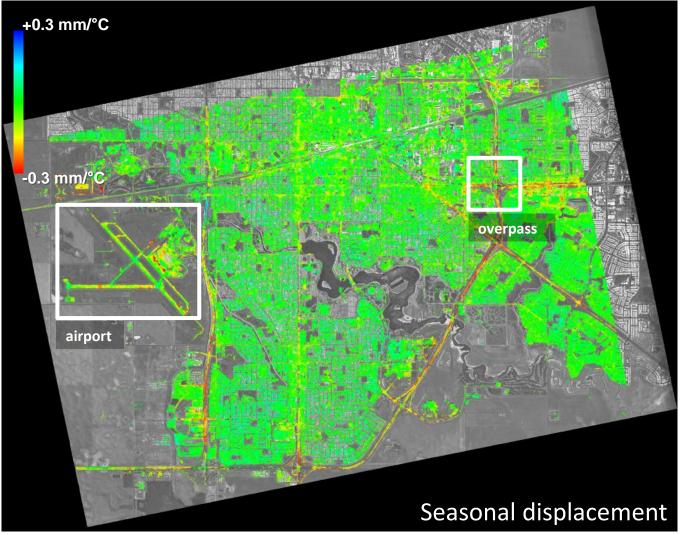
Regina Seasonal Displacement

- Indicate areas with strong frost heave which will require more frequent maintenance
- Separate out seasonal effects from long-term trends
 - Seasonal/temperature-dependent effects often included in engineering design
 - Subtle long-term trends could indicate current/future problems
 - Displacement will eventually exceed tolerances

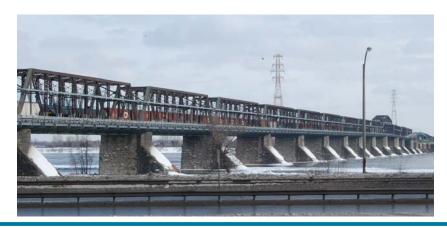
Victoria Bridge as viewed from Montreal Technoparc (on Nuns' Island. South of bridge)

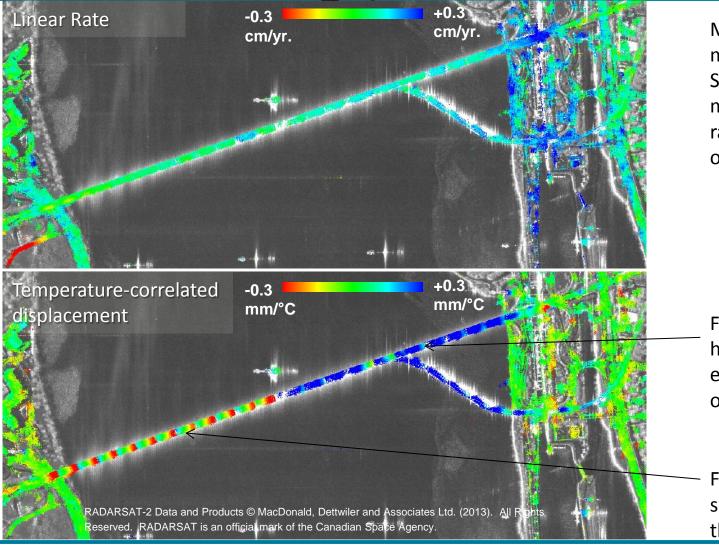
Victoria Bridge, Montreal

Minimal linear rate on majority of bridge. Some (Westward?) movement towards radar LOS on East side of bridge

Fixed joints on righthand side allow expansion to the West only

Fixed joints on left-hand side allow expansion to the East only
