United Nations/Islamic Republic of Iran Regional Workshop

Remote Sensing for Assessment and Evaluation of
geomorphological Hazards with Reference to Floods
for Eastern Part of Khartoum State – Sudan

Eltayeb Osman Adam Abdalla

Remote Sensing Authority

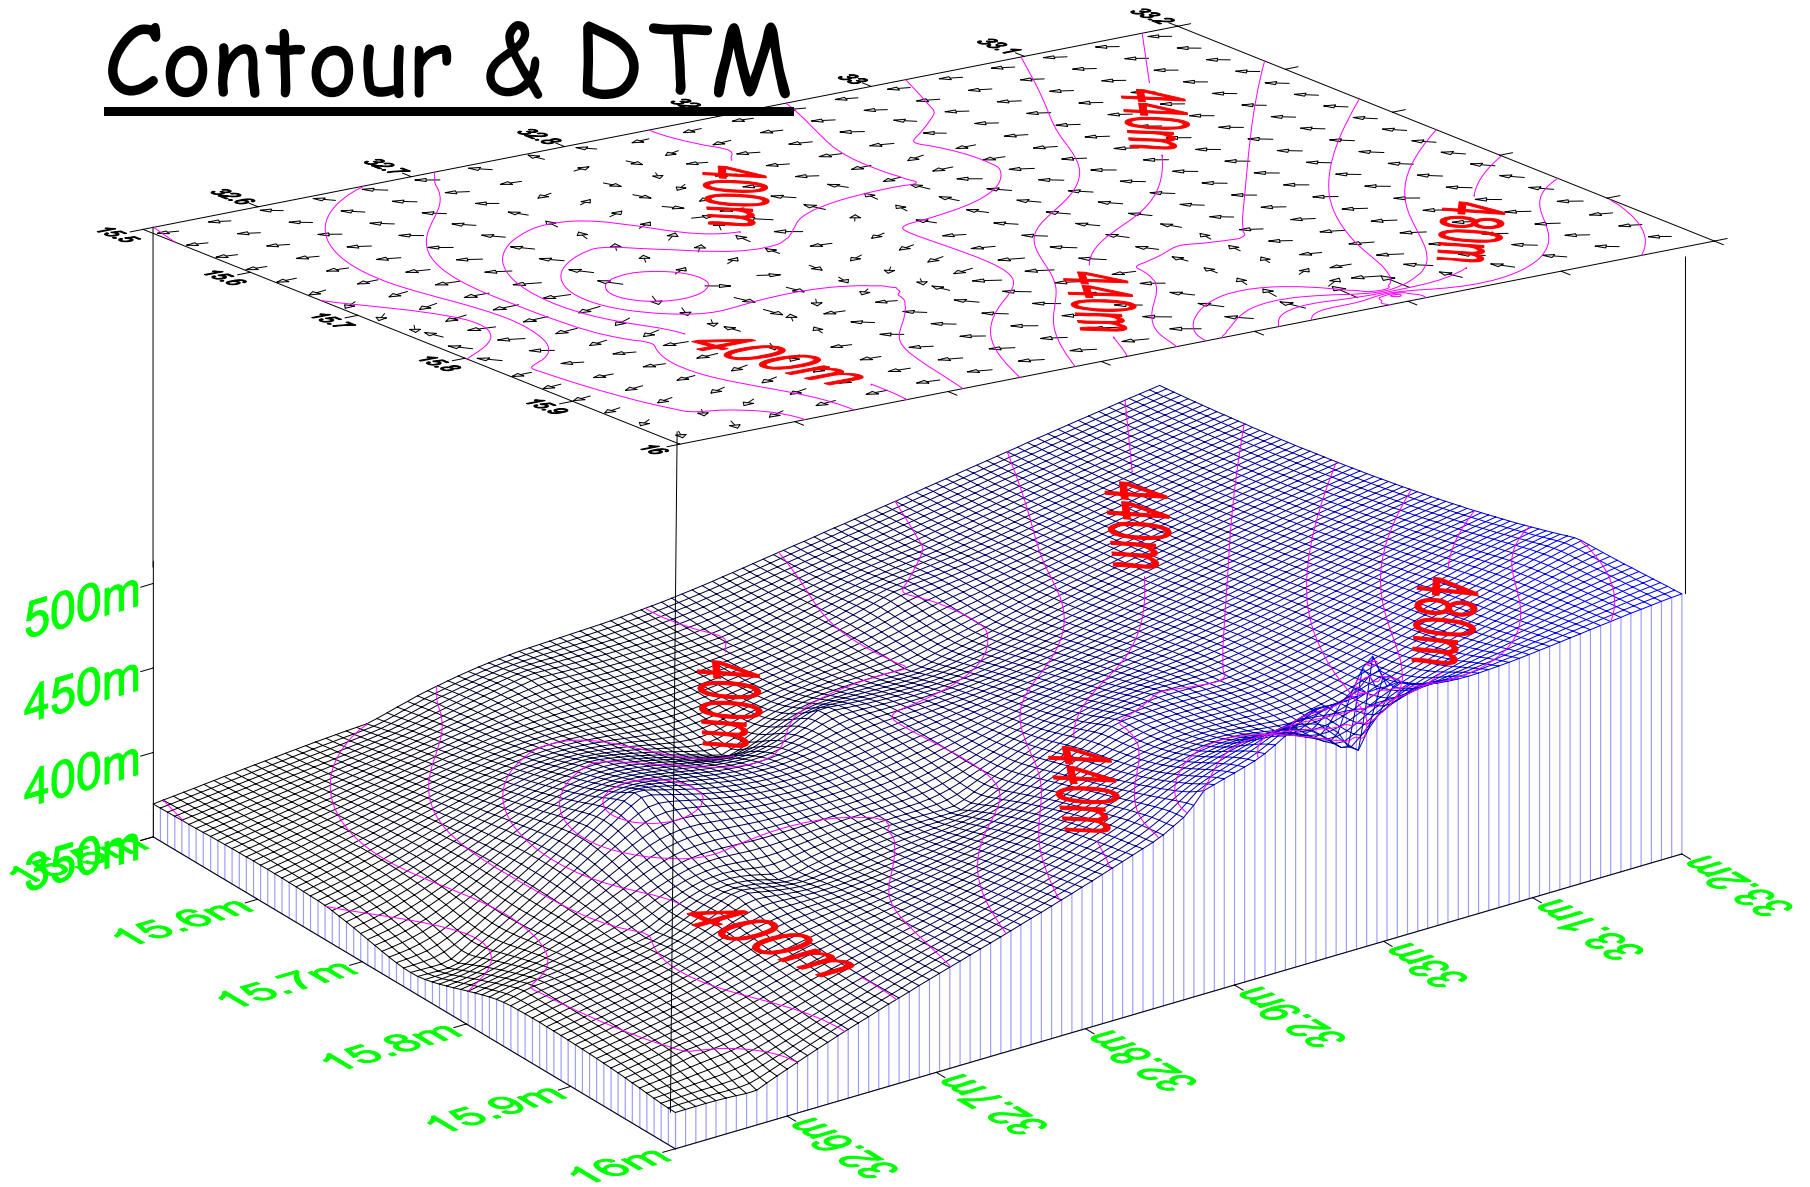
Contour & DTM

Graduated slopping towards Nile and Wadis flow direction
